Planning a Beach Nourishment Project Using GIS in Ponte Vedra Beach, FL

Presented by:
Bryan Flynn, EI
Matt Starr
Todd DeMunda, EIT
Jeffrey Tabar, PE

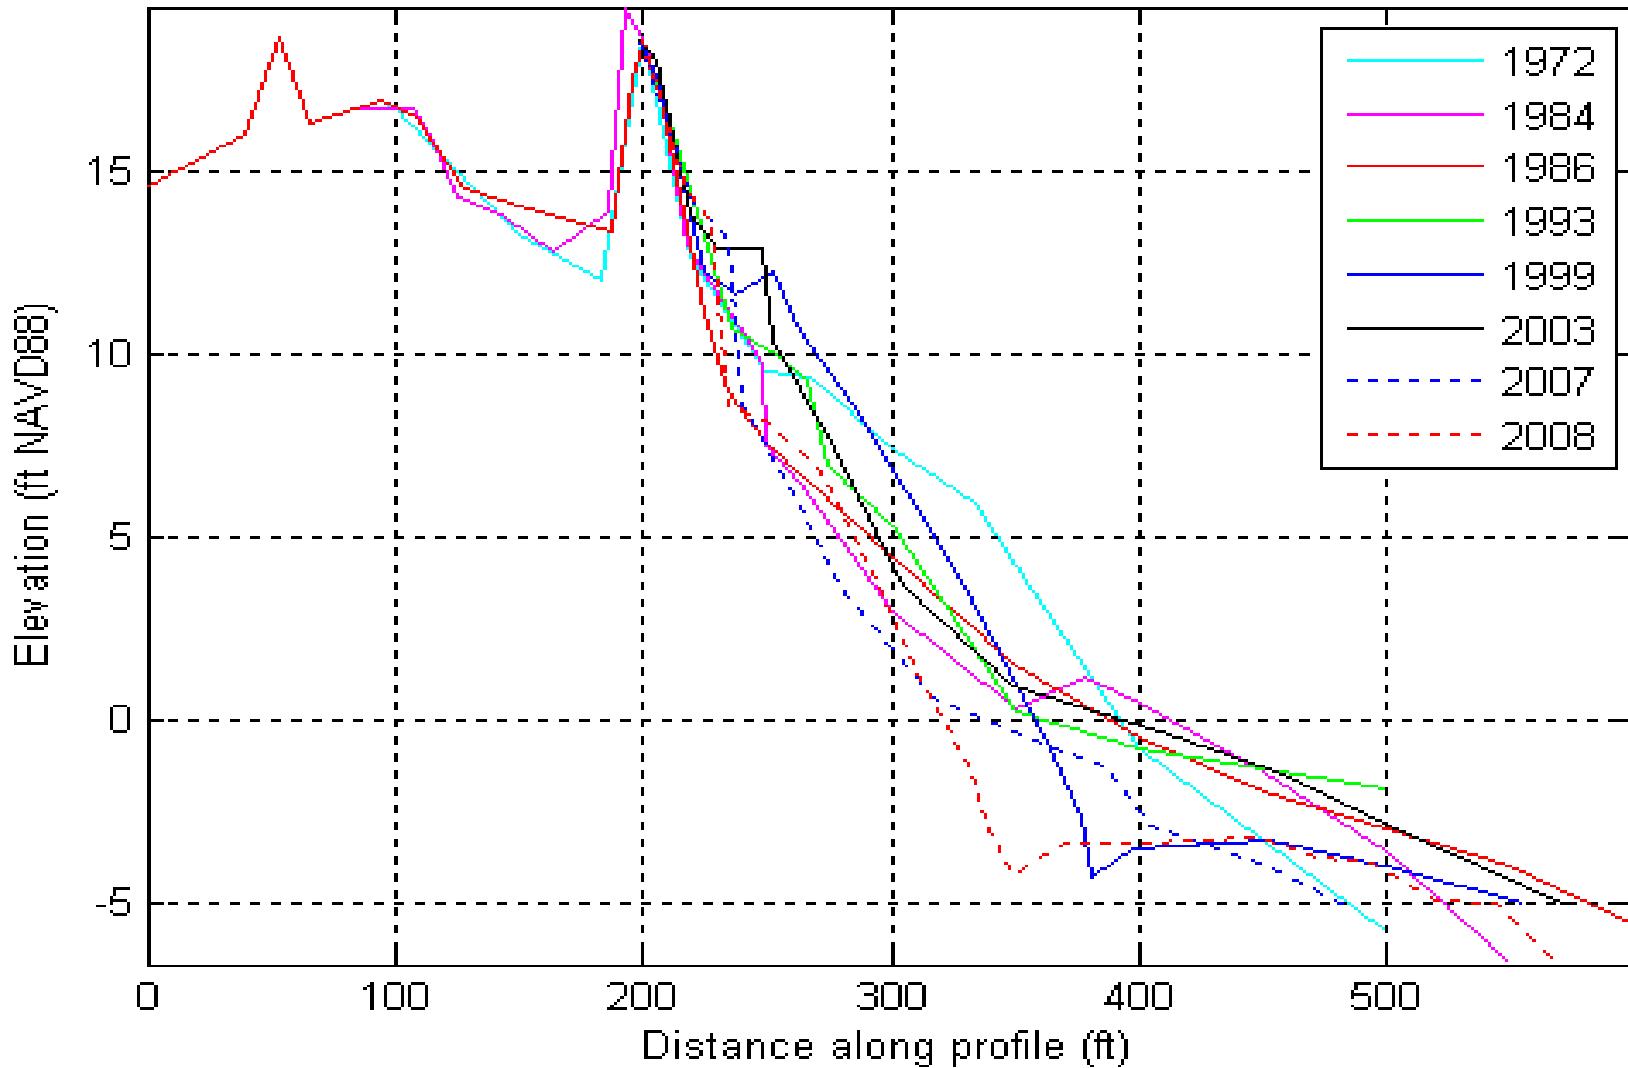
St. John's County
Profile R-87

Beach Profile Data

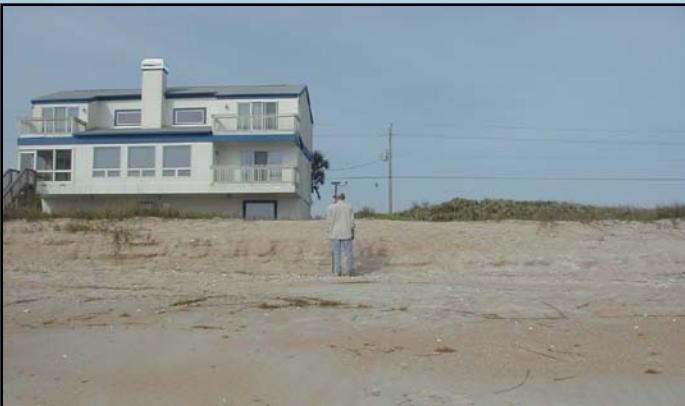
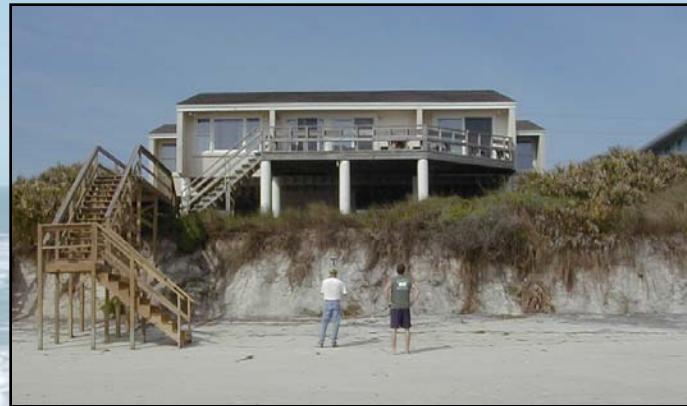
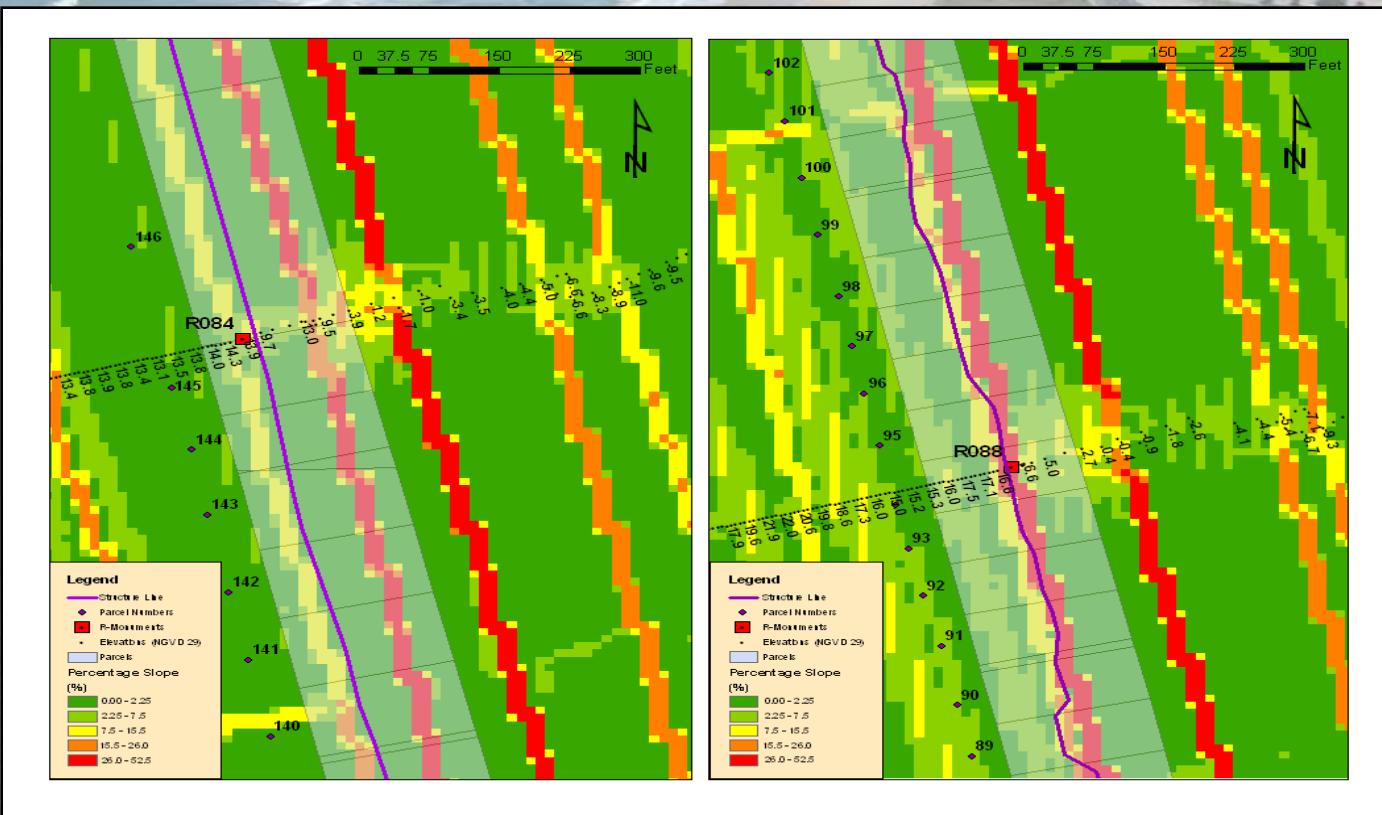
GIS Slope Analysis

- Protect residences that are unstable
- Slope stability analysis modeled in geotechnical report
- Utilized GIS to graphically depict the results of the geotechnical report for presentation to county and residents

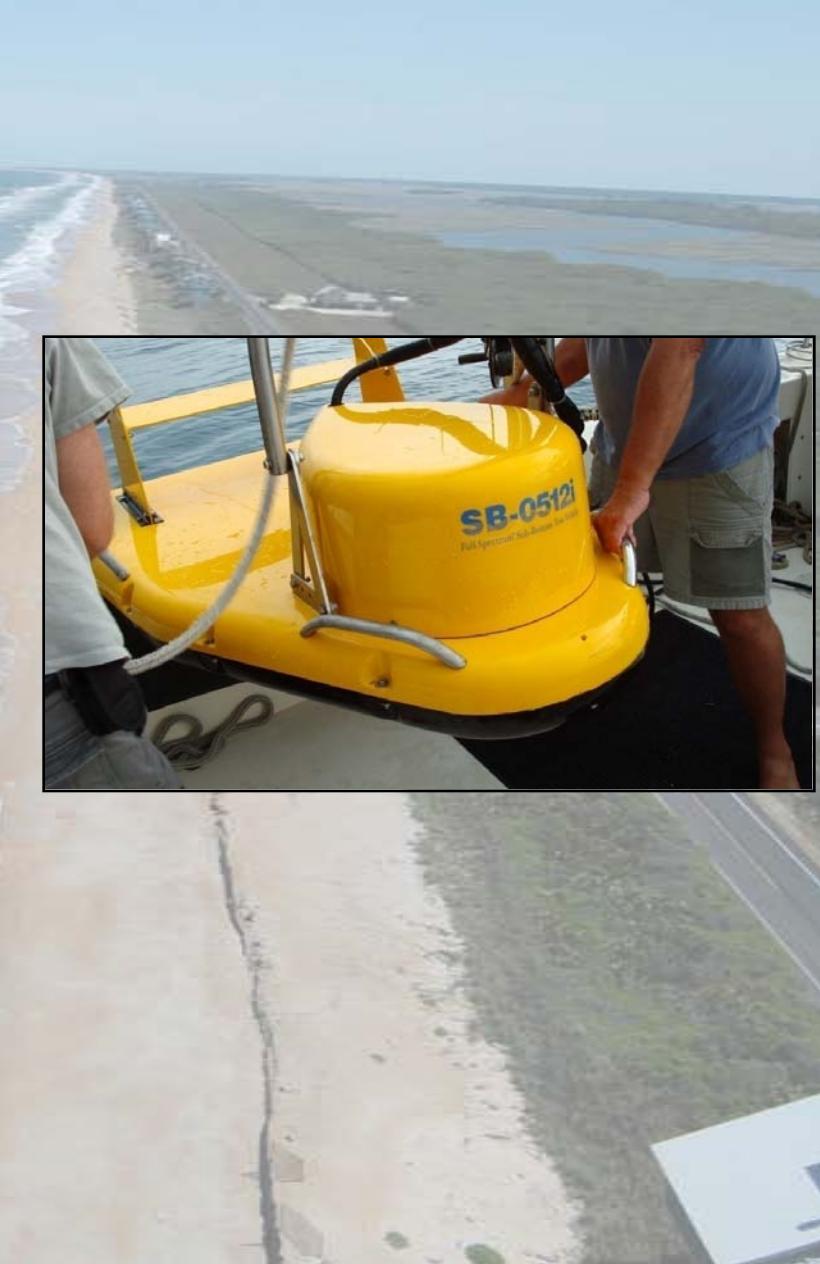
Sand Resources

- Five sand shoals identified
- Beach compatibility
 - Native 0.23mm
 - Shoals: 0.17mm to 0.27mm
- Total volume: approx: 80 million cubic yards
